Manhole Inspection Summary

Manhole # S45UU_007MH

Insp Date: **2/8/07 9:23 AM**

Location Address: **2729 THE ALAMEDA**

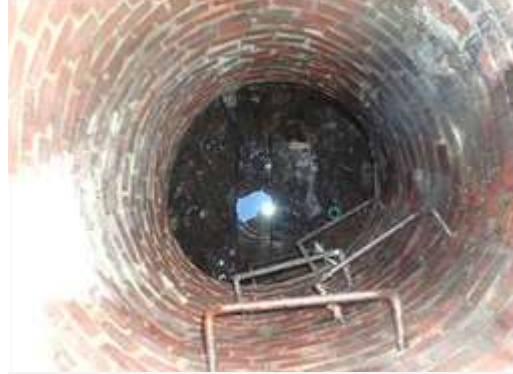
Top View

Corroded steps. Evidence of surcharge - Bench debris. Channel debris.

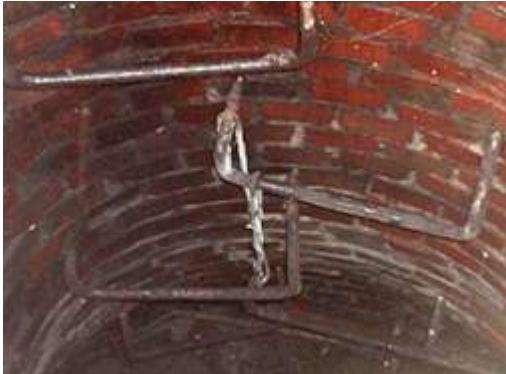
Defect

Barrel infiltration.

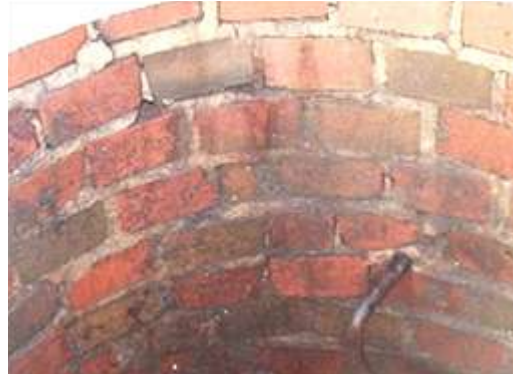
Defect

Adjustment deterioration and infiltration. Corbel infiltration.

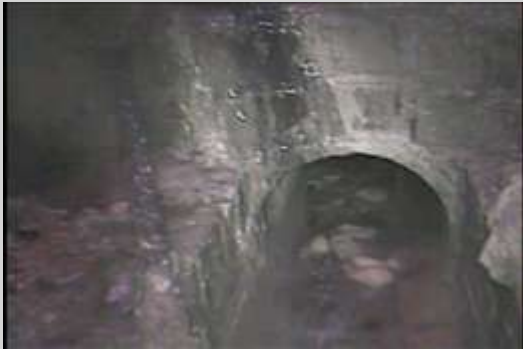
8 in. Circular Gravity Sewer Pipe Out @ 12 O'Clock

Deposits: ☐ None ☒ **Mud** ☐ Sludge ☒ **Debris** ☐ Grease

Silt Depth: **0** (in.) Deposits Extent: **Light**

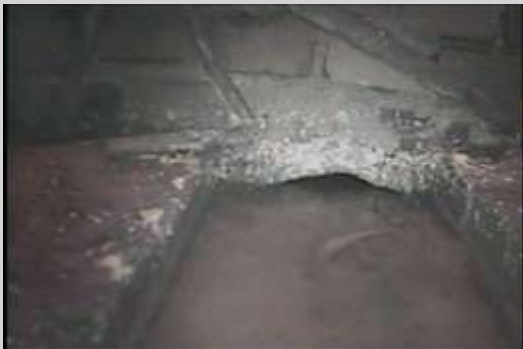
8 in. Circular Gravity Sewer Pipe In @ 6 O'Clock

Deposits: ☐ None ☒ **Mud** ☐ Sludge ☐ Debris ☒ **Grease**

Silt Depth: **3** (in.) Deposits Extent: **Medium**
